# MEMBRA DISIECTA. ROMAN LITHIC FRAGMENTS IN HAȚEG (Part II)<sup>1</sup>

MONICA MĂRGINEANU CÂRSTOIU, VIRGIL APOSTOL, ȘTEFAN BÂLICI

## Ostrov (Municipality of Râu de Mori). The enclosure of the Church of the Descent of the Holy Spirit

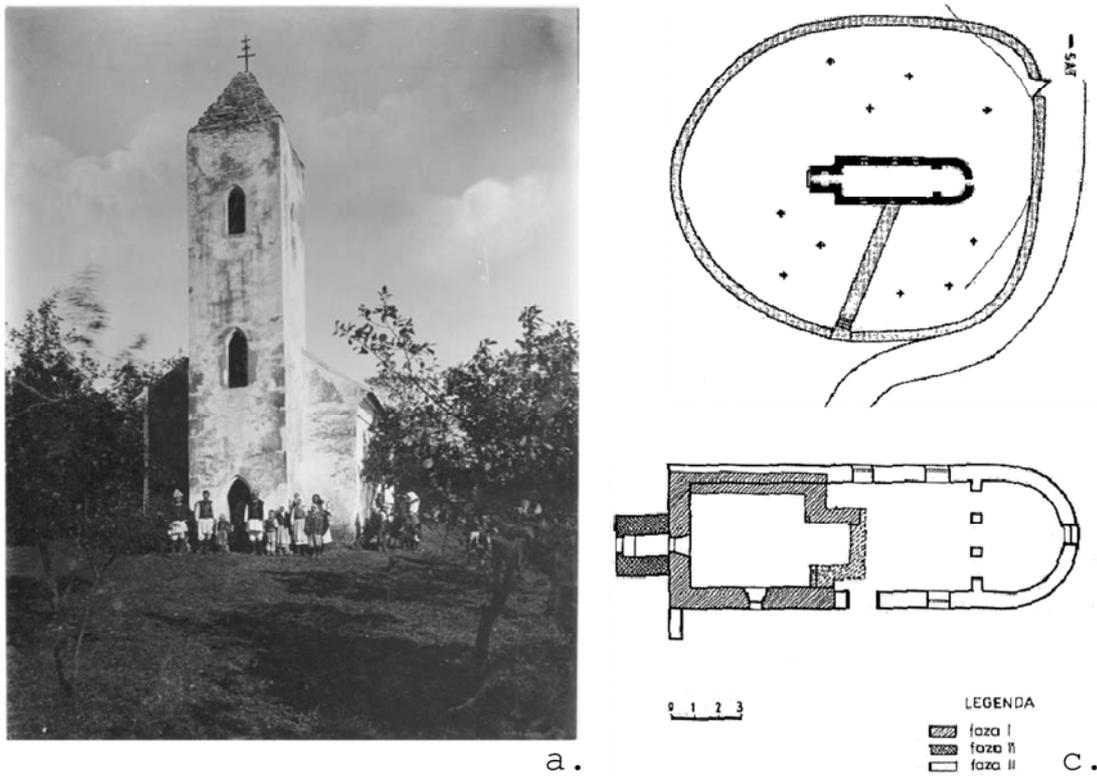
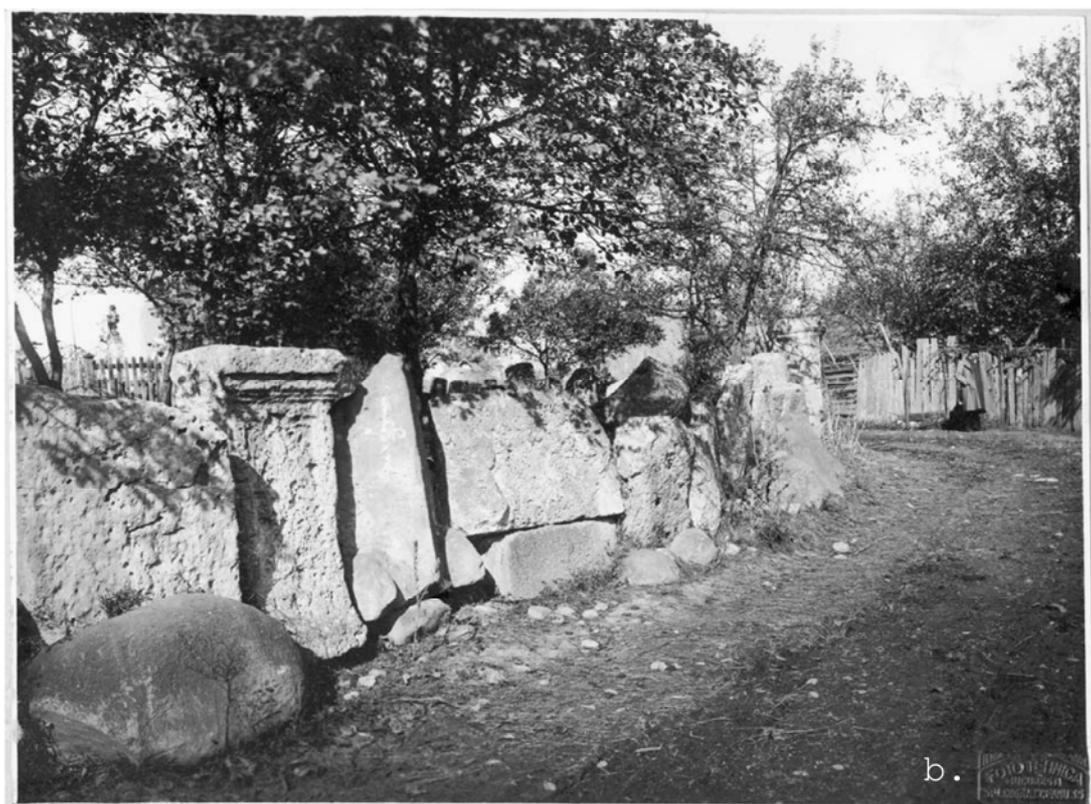
Fig. 1. *a* The Church in Ostrov; *b*: detail with the enclosure - block no. inv. 27 (photograph taken in 1933, The Archives of The National Institute of Historic Monuments, File DMI); *c*: The plan of the church and of the enclosure cf. A. A. Rusu, *Ciitori și biserici din Țara Hațegului până la 1700*, Satu Mare, 1997, fig. 32, 34, p. 238, 240).

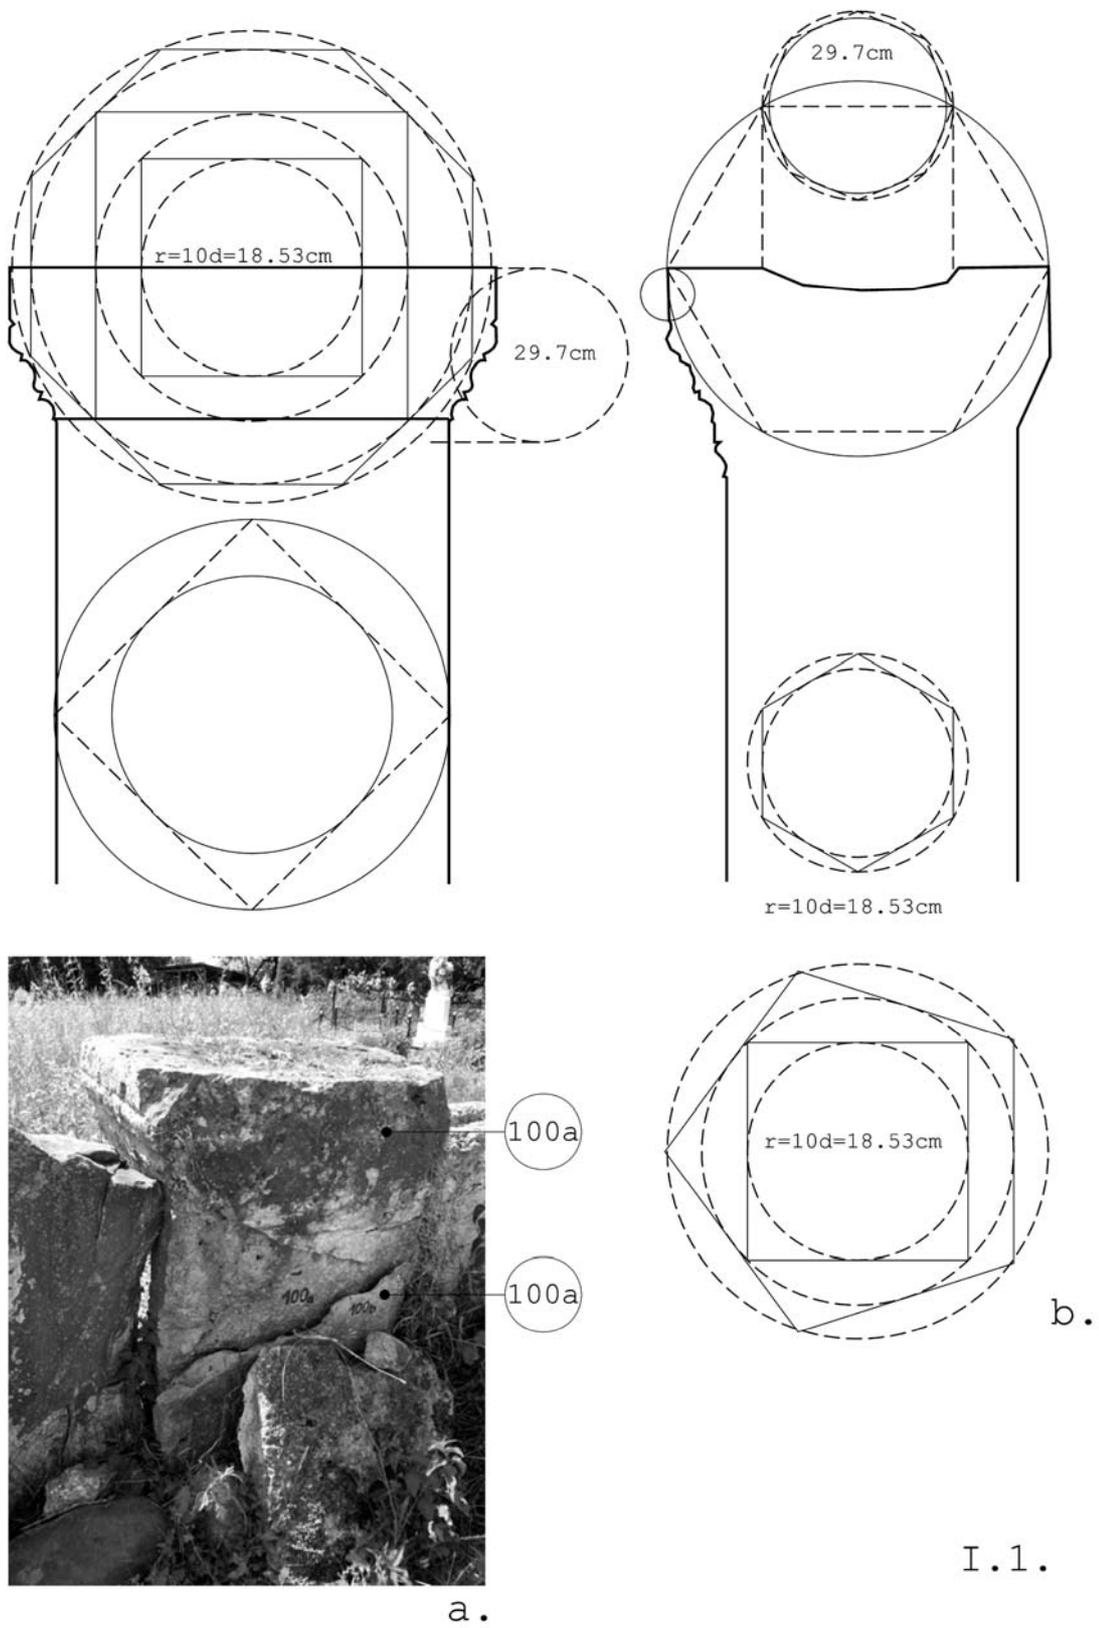
Fig. 2. *a* Altar I.1. (inv. no. 100a, b); *b* geometric support.

Table 1: *Unit of measurement and geometric support* (Fig. 2b)

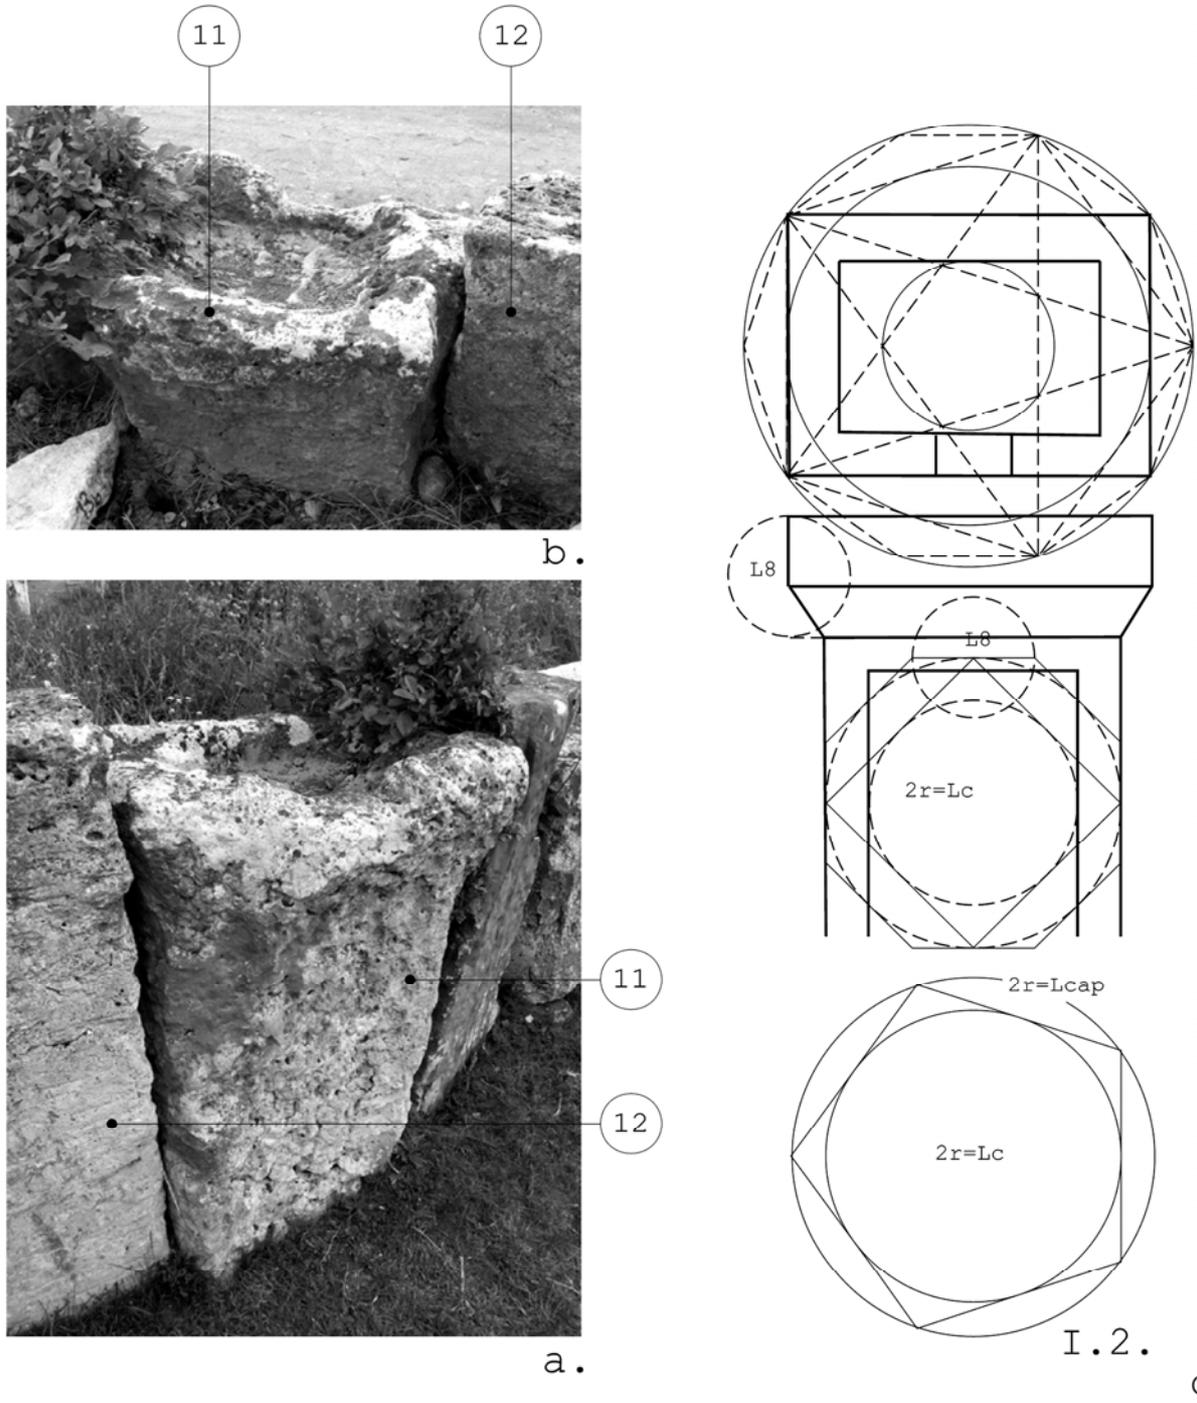
Fig. 3. *a* Altar **I.2.** (inv. no. 11); *b*: cavity detail *c*: geometric support.

Location: included in the north-east sector of the enclosure, adjacent to gate B

A block representing an altar or a commemorative monument, with capital. The lower part of the shaft and the base are buried in the ground. The bedding surface is badly damaged, preventing any remark on the nature of the long, flat clamp-shaped groove. Thus, it is not possible to decide whether this groove is the result of a secondary use of an altar, or it has been destined to fasten a commemorative or votive sculpture. The edges of the upper part of the capital are obliquely cut, giving the suggestion of a flatted truncated pyramid, with the regular flat register unfolding beneath. The moulding, coming from a *cyma reversa* ( $ls/hs=0.604$ ), underwent a formal deviation through the hypertrophying of the concave part; an oblique ( $45^\circ$ ) listel and a small cavetto connect it to the shaft. The central panel is flanked by a talon ( $lt/ht=0.396$ ), followed by the usual flat “ribbon”. The side face (right) is broken. The block bears traces of secondary use. Before its adding to the enclosure, it had been cut off after a plane parallel to the façade. This action may be the result of a secondary use<sup>34</sup>. Nevertheless, the hypothesis of its sectioning by those who brought the block to the enclosure cannot be excluded.

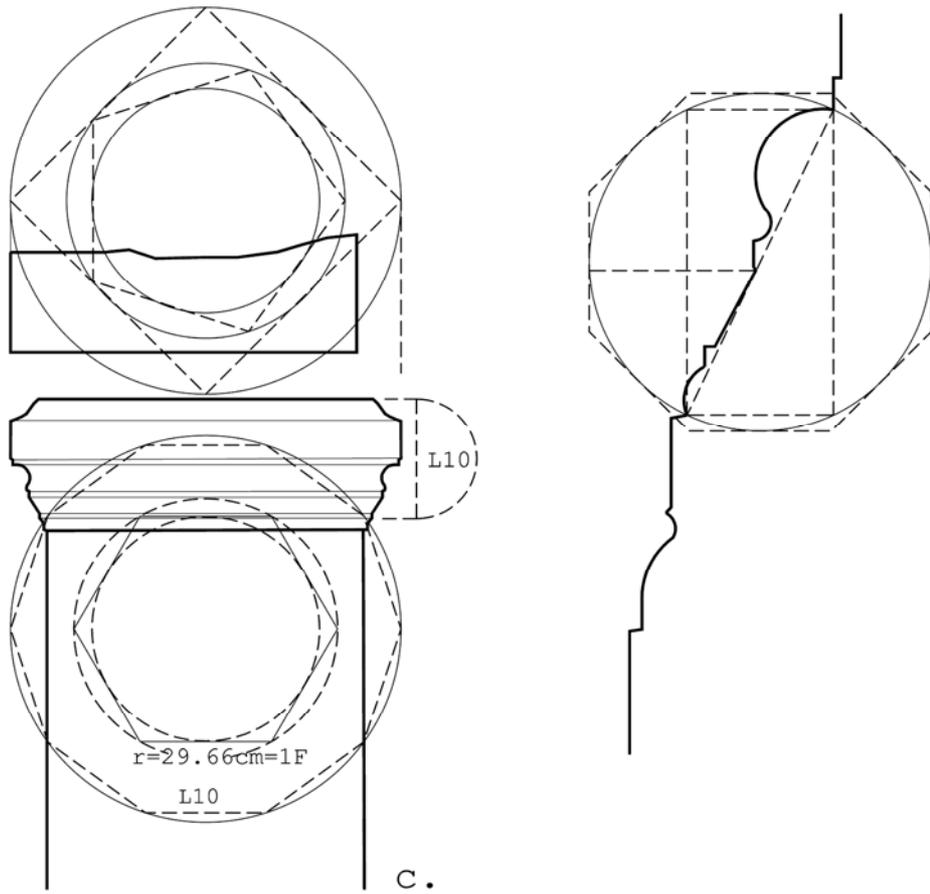
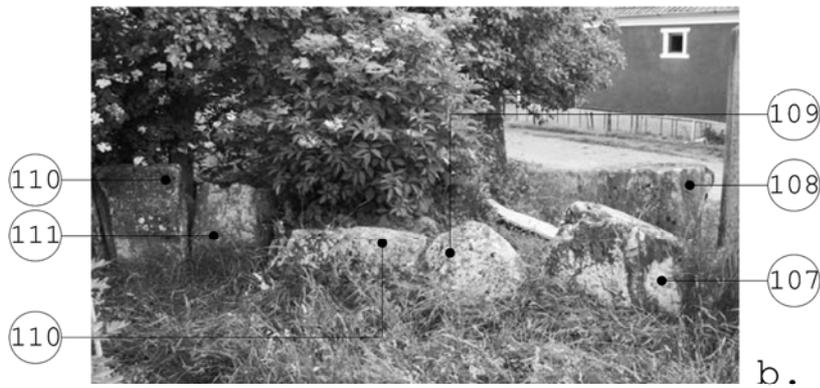
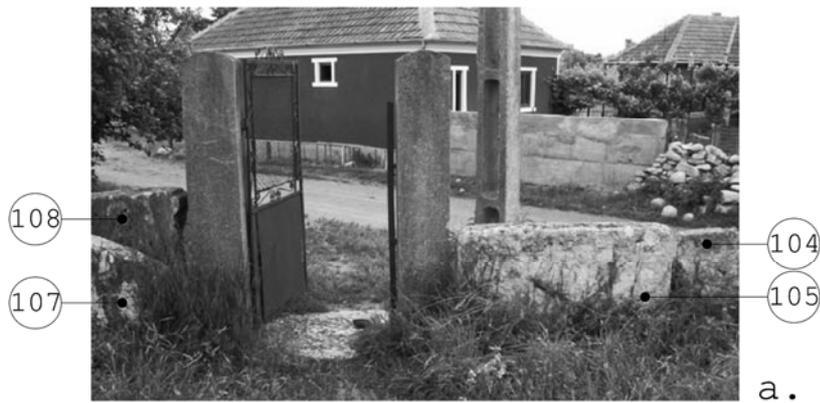
Fig. 4. a, b Altar I.3. (inv. no. 108); c geometric support.

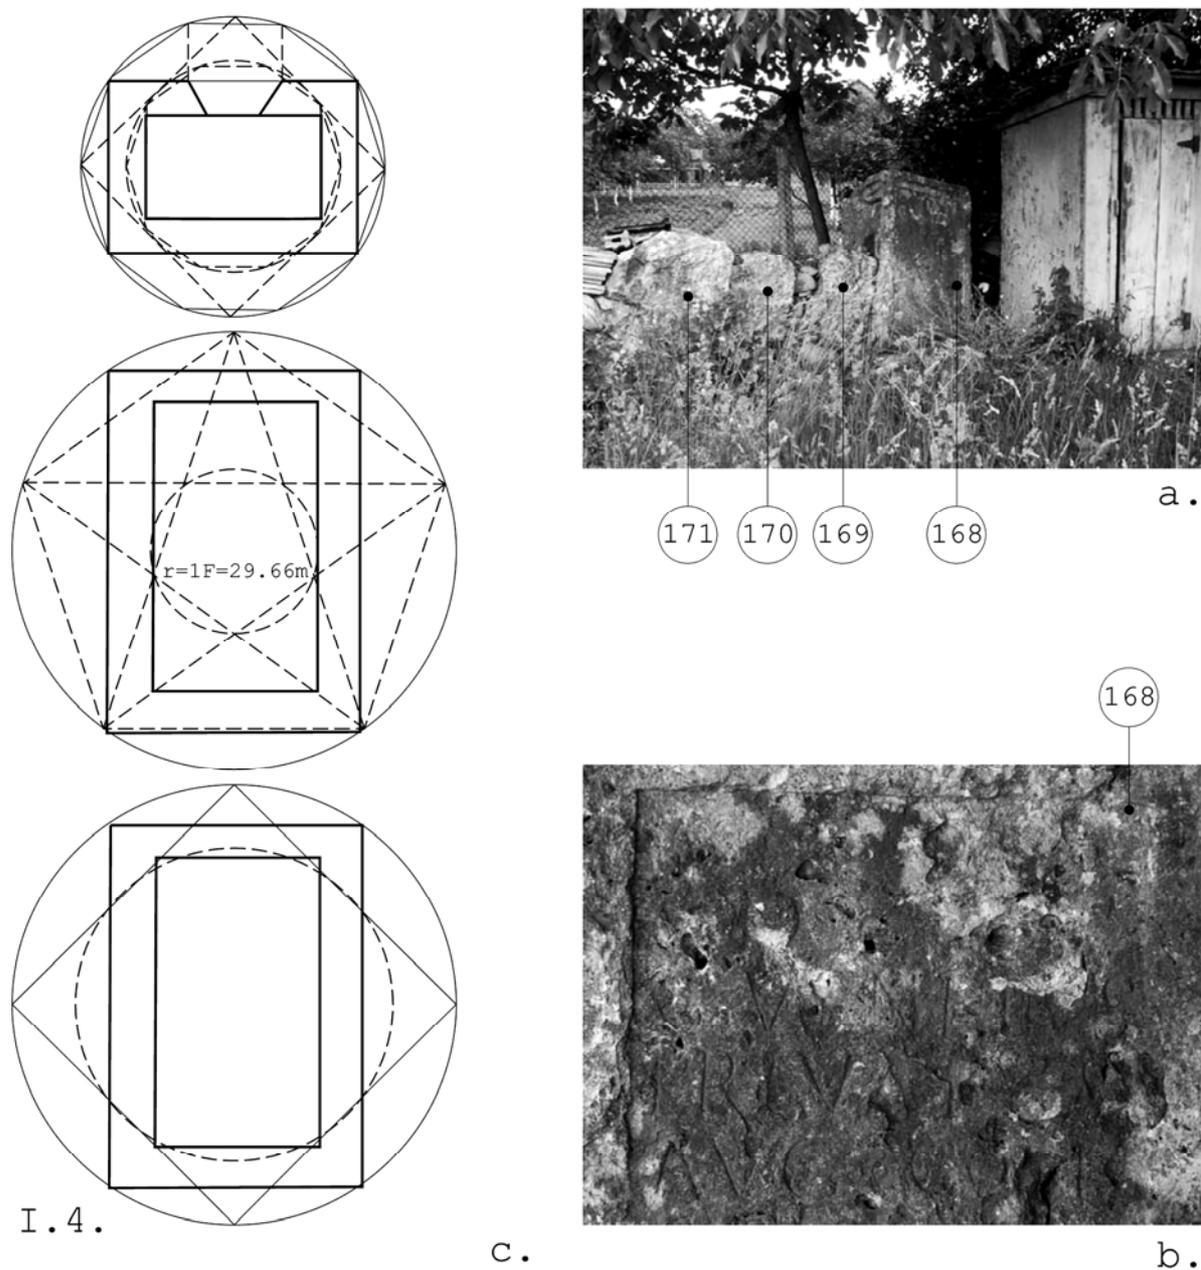
Fig. 5. *a*: Altar I.4. (inv. no.168); *b*: inscription detail; *c*: geometric support.

Rectangular altar without capital. A small fraction of its lower part is buried in the ground. The votive table is strongly carved out, to a maximum depth of 16cm; the perimetric frame – partly broken – provided for an opening (trough), approx. 27cm long, opening onto the rear face. On the faces of the shaft the central panels are conserved, surrounded by an overturned talon and a flat “ribbon” along the edges. The curving of the talon is distinct from all others found at monuments of this type in Ostrov ( $l_t/h_t=0.871$ ). The side faces have their perimeter frame, in their lower third, approx. 57cm in height, hewn and unfinished. The rear face is treated in a rougher manner, proving that this face was not meant to be seen. The mouldings, unfinished on the sides, suggest the possible existence of access steps to a “platform” adjacent to the rear side. The altar table – because of its height from the base – would have been inaccessible for the performing of rituals in absence of these steps. According to this conjecture, the height of the rear platform – i.e. of the altar in its functional area – is 94cm.

This monument gives very important evidence to the history of the enclosure. This was already put up in the 18<sup>th</sup> century, when it was seen by Major Hochenhausen who, given his interest in epigraphic pieces, copied its inscription.<sup>37</sup> On the other hand, due to the interest arisen by the inscription, this monument became a witness to the velocity of the dramatic wearing out of the fragments that make up this highly original ensemble: during the interval between I. I. Russu’s documentary trips of 1967, 1972 and 1977 and the moment of our field research, in 2004 – 2005, the erosion of the inscription was so intense as to efface part of the letters so clearly visible in the photograph published in IDR.

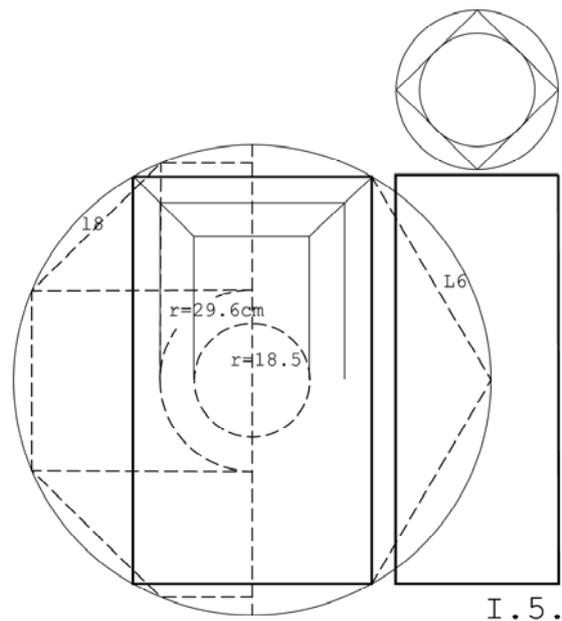
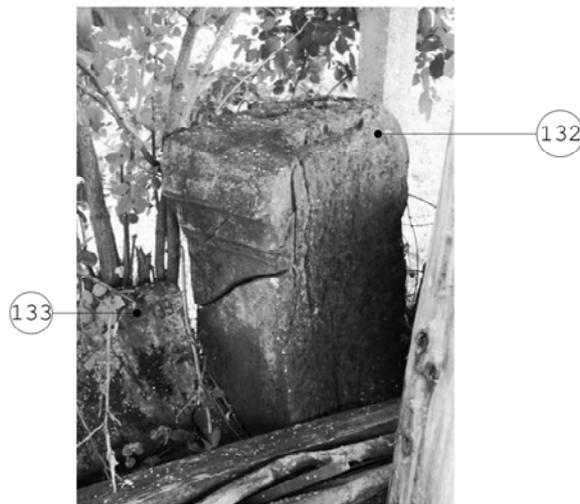
Fig. 6-7. Altar **I.5.** (inv. no.14); geometric support.  
Pedestal (funerary monument) **I.7.** (inv. no.132).

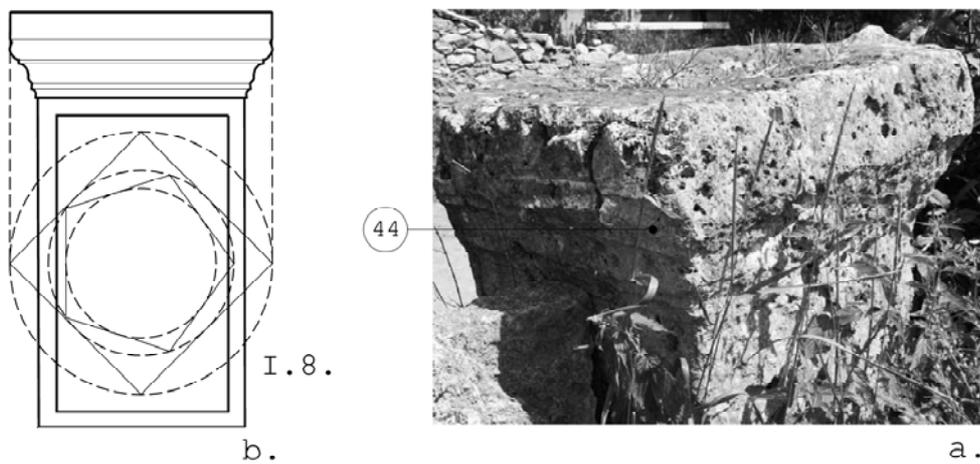
Fig. 8. *a*: Pedestal (funerary monument) **I.8.** (inv.no. 44); *b*: geometric support.

The base buried in the ground. The capital is comprised of a flat plateau, 9.6cm high and a round listel followed by a *cyma reversa* with less decided outlines (ratio ls/hs=0.725); the shaft is surrounded by an overturned talon (lt/ht=0.472). The rear face is unfinished, indicating the position of the pedestal against a wall.

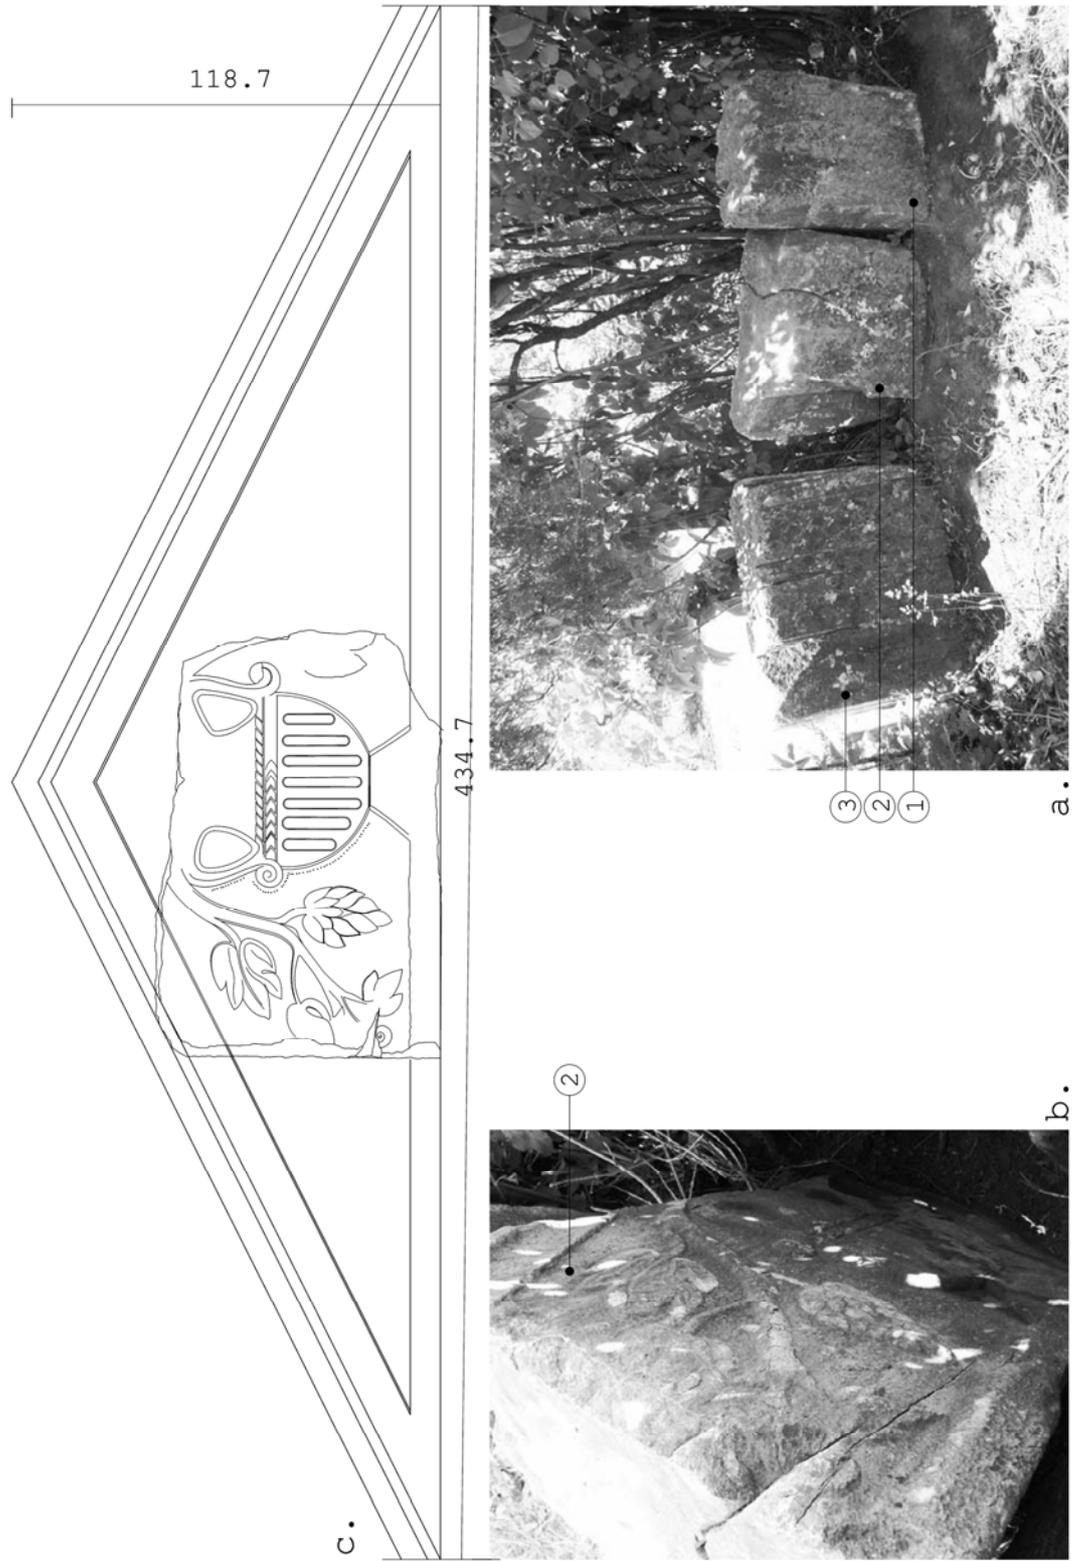
Fig. 9. *a, b*: Funerary monument pediment **II.1.** (inv. no.2); *c*: reconstruction (hypothesis).

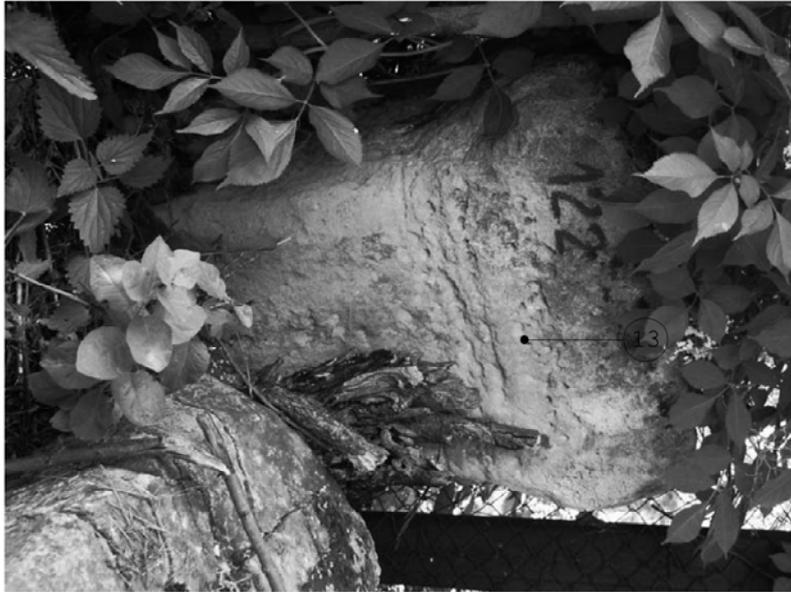
Fig. 10. Funerary stele **II.2.** (inv. no. 13 a, b, c).

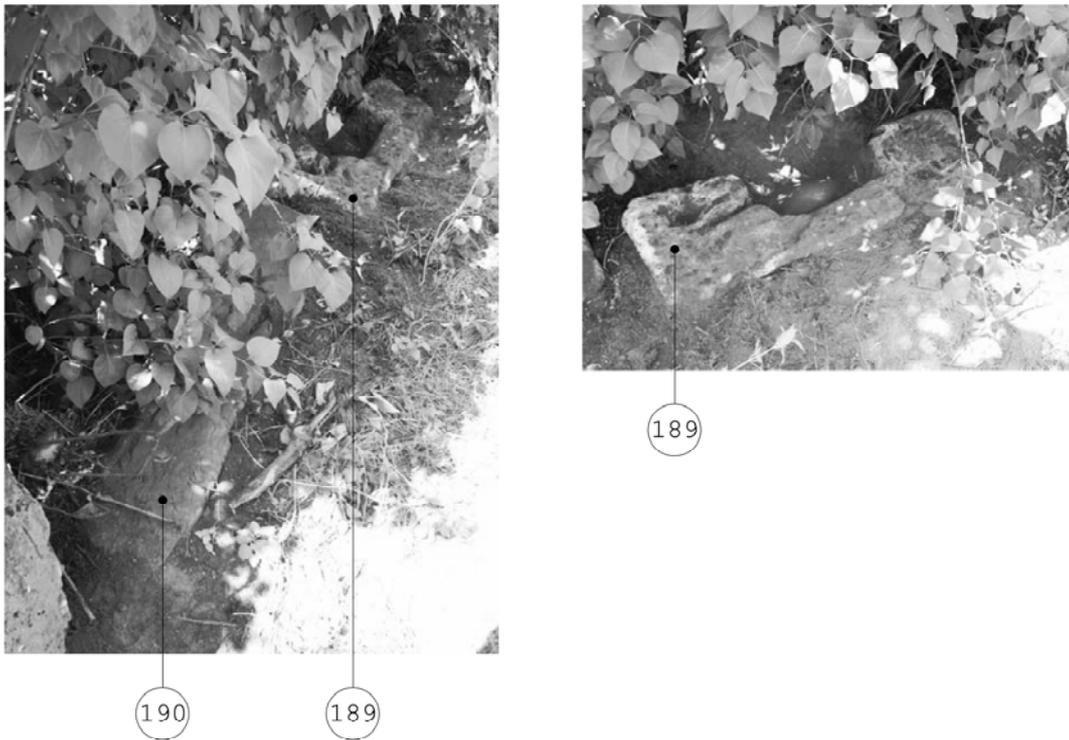
Fig. 14. Stele pedestal **II.9.** (inv. no. 189).

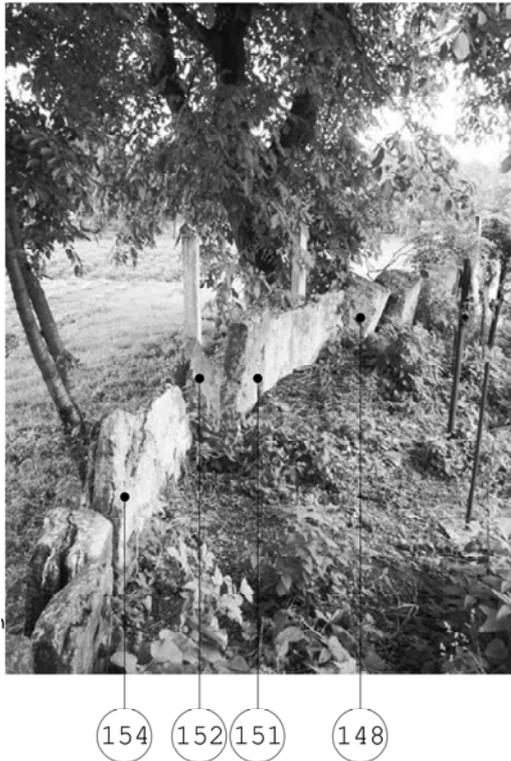
Fig. 15. Corner block **III.2.** (inv. no. 152).

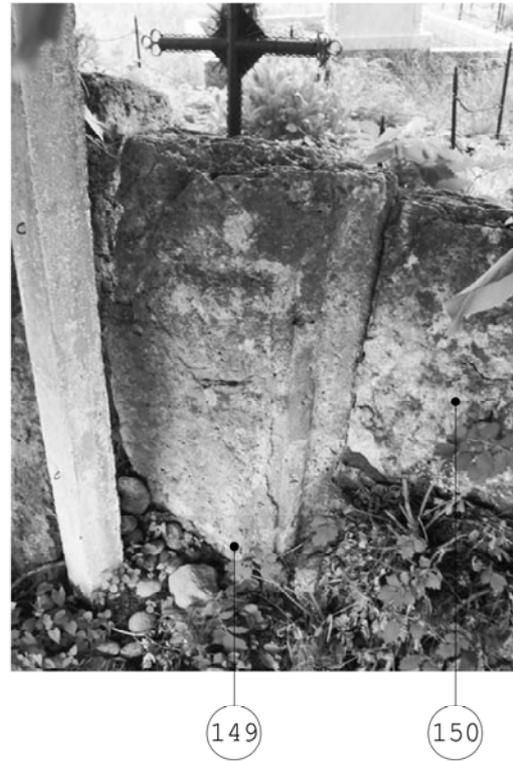
Fig. 16. Moulded base **III.4.** (inv. no. 149).

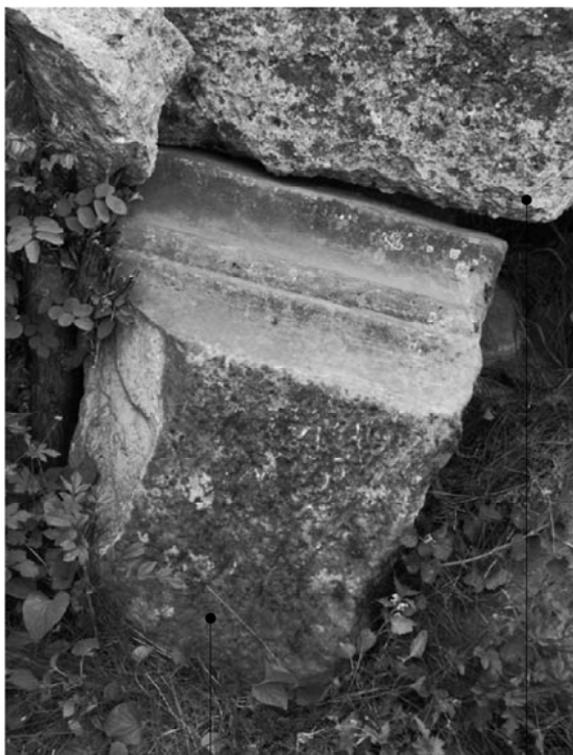
Fig. 17. Horizontal cornice **IV.5.** (inv.no.76).

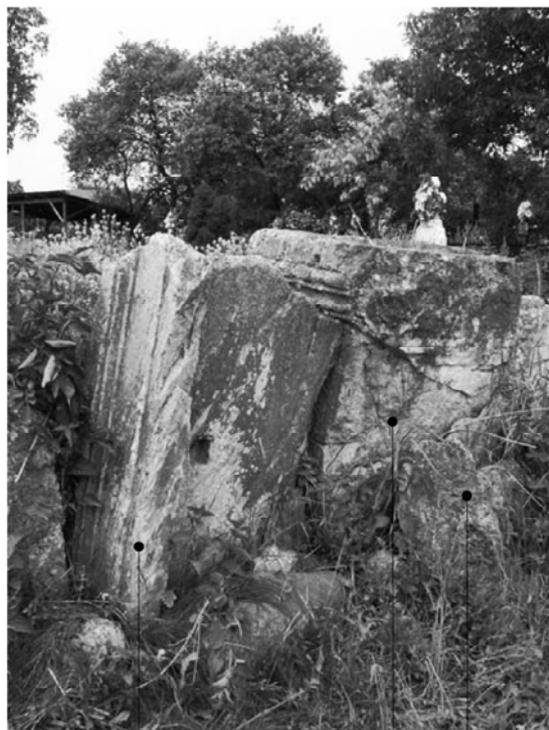
Fig. 18. Block with architraved decoration **V.1.** (inv. no. 99).

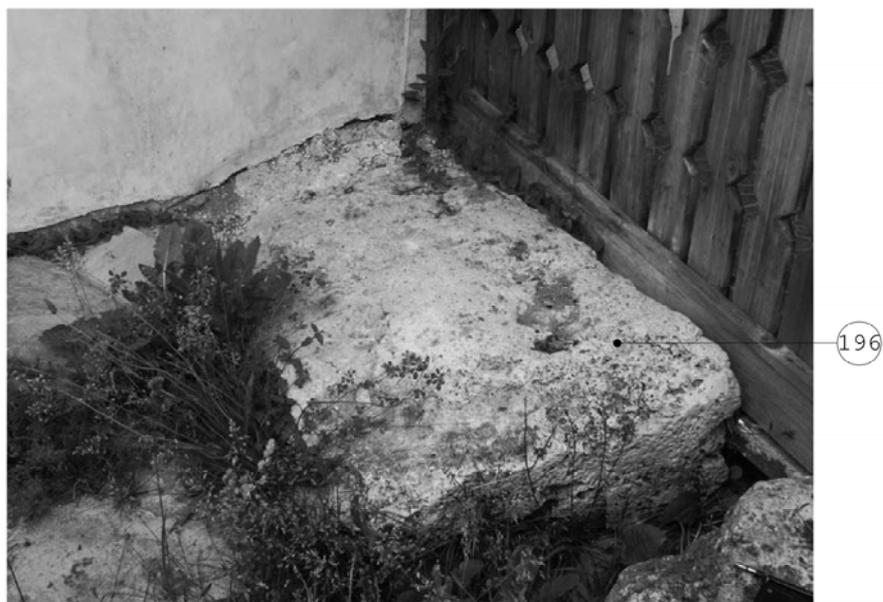
Fig. 19. Architrave **V.2.** (inv. no. 196).

Broken at both ends. It reproduces a type of ionic bipartite architrave; its crowning comes from a *cyma reversa* with hypertrophied concavity and with the ratio  $ls/hs=0.411$ ; above this moulding lie two flat registers, consecutively projected. The resting surface is surrounded by a border, 11.5cm wide and 5-6cm high; close to it, on the same surface, there is a mounting groove (7.5cm/?/6.5cm). The aspect of the crowning, and especially that of the lower surface is not compatible with a proper architrave, but it may be suited for a funerary monument – crowning of an altar table or of a table-tomb (*tombeau-table*)<sup>47</sup> (Pl. XXIII a, b).

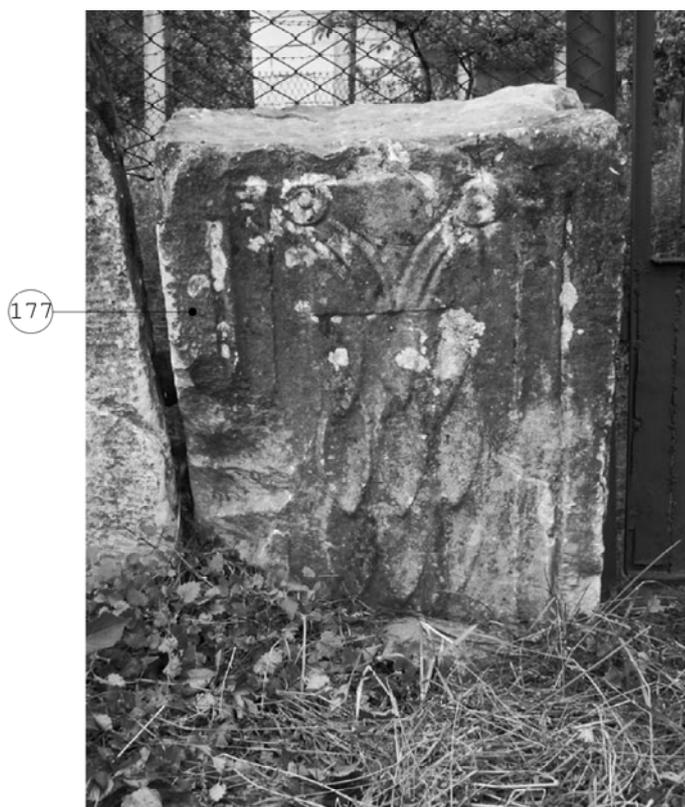
Fig. 20. Block with laurel leaves VI.2. (inv. no. 177).

Following another conjecture, block **VI.2.** is set upright, making decorative pilasters. (Pl. XXIIIb) In this case one must either accept that the clamp groove is resulted out of secondary use, or consider it as belonging to the original monument, but used atypically. Such an utilisation can be accepted if the block necessitated repairs, maybe even during the construction of the monument, the clamp tying, vertically, two fissured or even broken fragments.

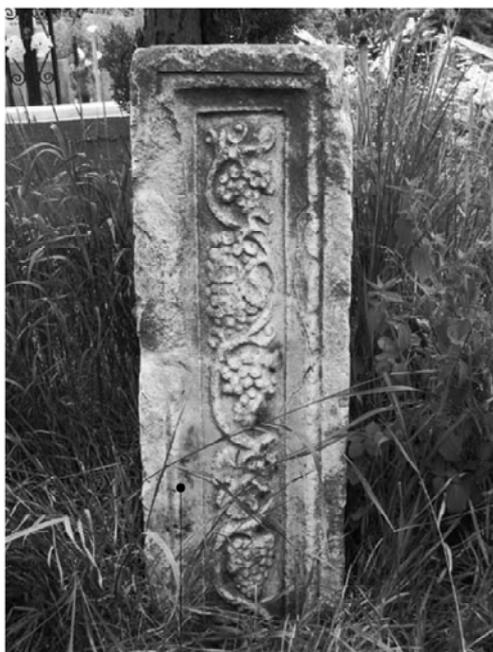
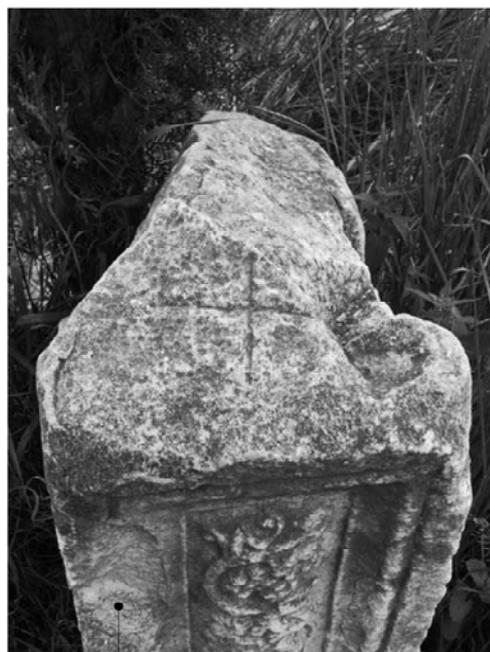
Fig. 21. Decorated block VI.3. (inv. no. 194).
